## PINE GROVE BRIDGE

HAER No. PA-586

Wooden covered bridge, two span Burr arch-truss

## APPENDIX C: ENGINEERING REPORT

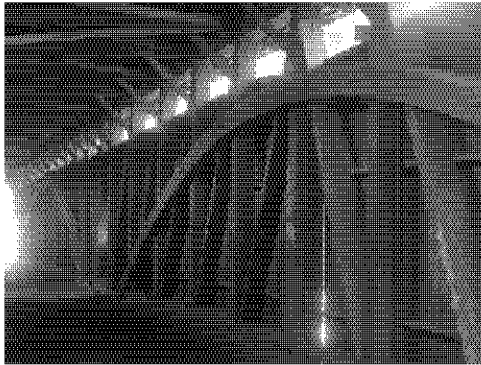
**Illustration 1.** Truss. Field photograph courtesy of author.

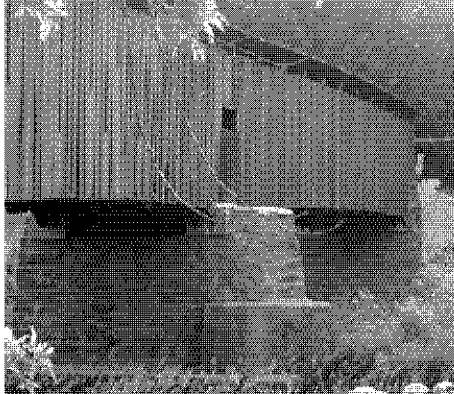
**Illustration 7.** Pier and northwest abutment. Field photograph courtesy of author.

The arches sandwich the lower chords on their way to their footing at the abutment. The arch ends meet a concrete block that is flush with the abutment or pier facing. Originally, the abutments and pier had a recessed cavity below the bridge flooring to receive the arch ends. At the abutments, these have been filled in with concrete. At the pier, the concrete only fills the area around the arch ends. The arch ends, which typically rot quickly, have been replaced over the years with wood and/or steel pieces. More recent knee braces join the arch ends to the first floor beam.

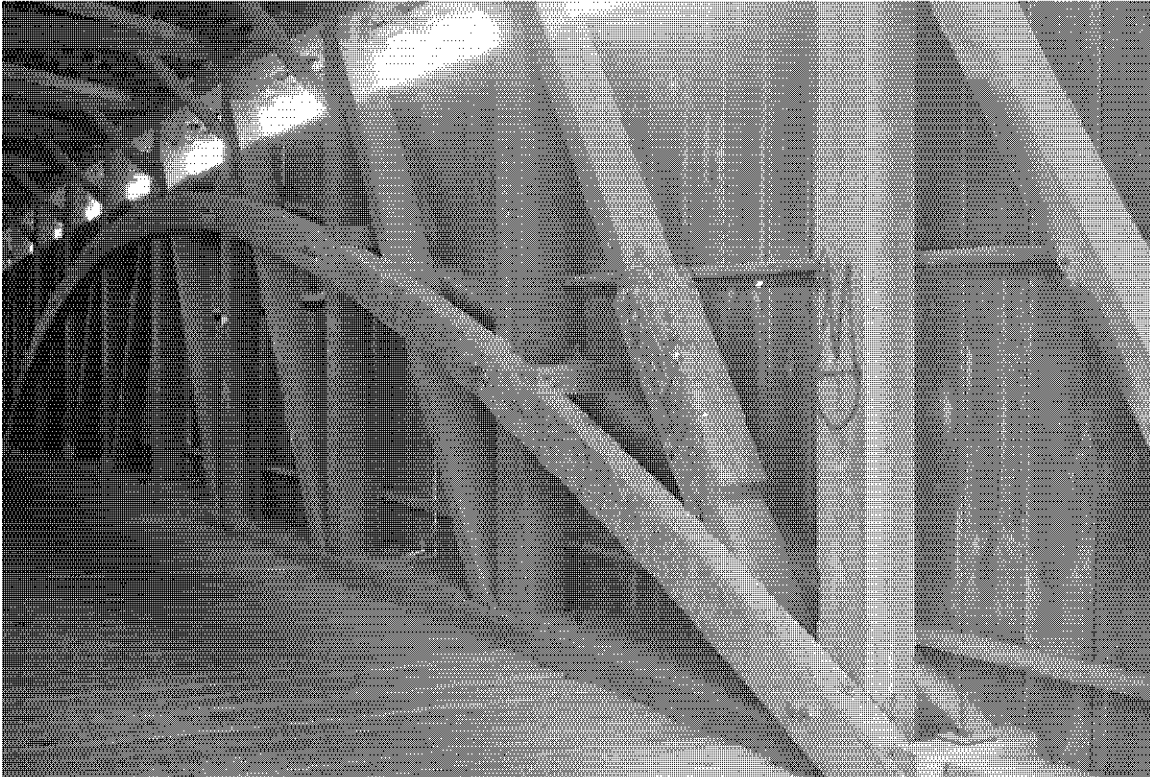
Figure 10. Arch-Truss Construction of the Pine Grove Bridge.

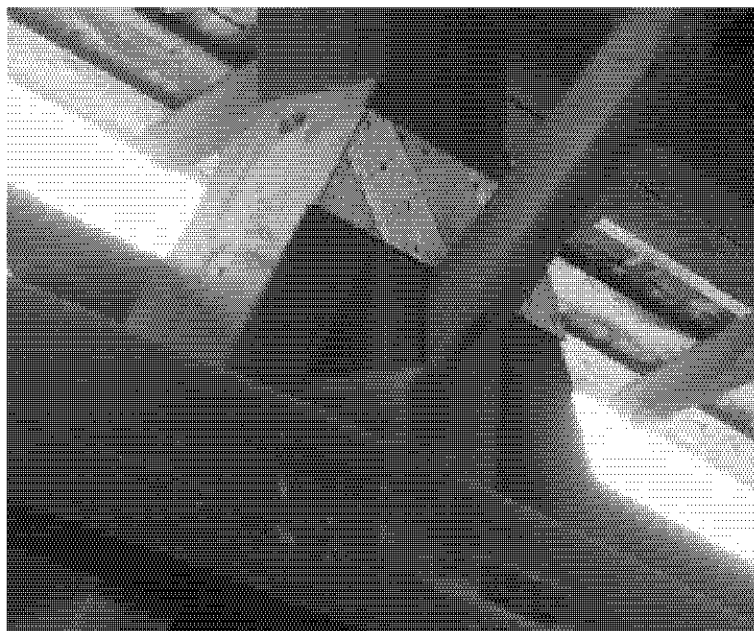
Field inspection of the bridge revealed a metal reinforcing patch at the mid-span intersection of the diagonals and post near the top of the post (Figure 35). This patch provides evidence of possible problems with these diagonals shifting, a likely scenario for an unloaded butt joint. In the case of the Pine Grove Bridge, its camber may have been beneficial for serviceability, but it could not guarantee optimal joint performance under all loading conditions.

Figure 35. Photo of Patch over Diagonal and Post Intersection at Mid-Span.
